Information to ASB2013/02/18

Containment Risk for Turbochargers with Grey Cast Iron Casings

MAN Diesel & Turbo SE
Business Unit Turbocharger

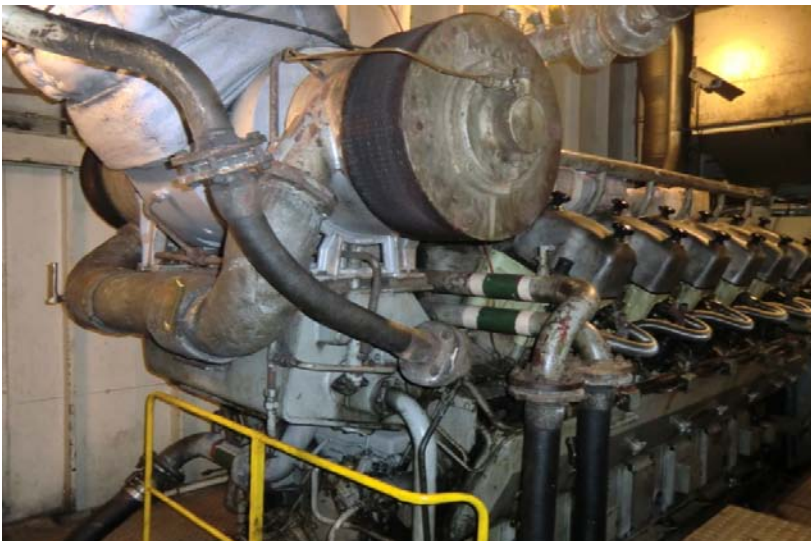
Before Retrofit: NR26/R

In most cases a turbocharger retrofit with a new TCR or TCA turbocharger is a viable option with the additional benefit of improved engine performance.

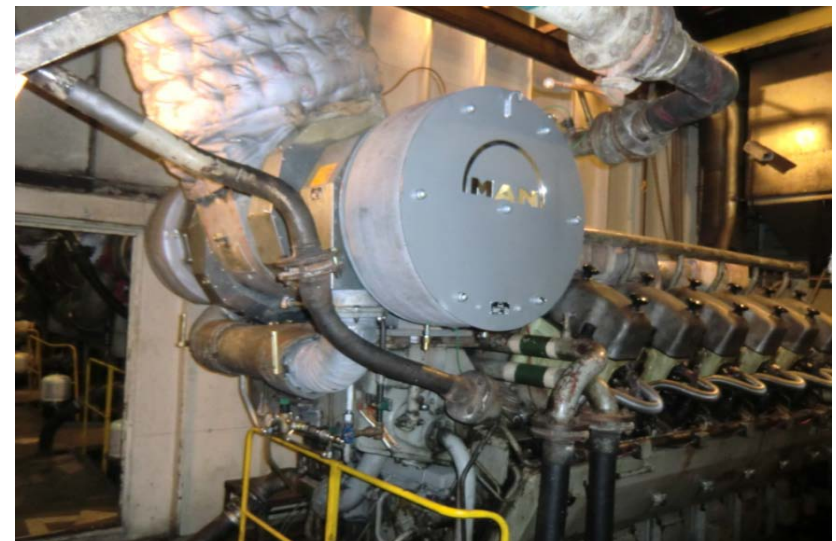
After Retrofit: TCR20-4
